Window opening effects on structural behavior of historical masonry Fatih Mosque

Alemdar Bayraktar, Emin Hökelekli, Temel Türker, İsmet Çalik, Ashraf Ashour & Ayman Mosallam

To cite this article: Alemdar Bayraktar, Emin Hökelekli, Temel Türker, İsmet Çalik, Ashraf Ashour & Ayman Mosallam (2019) Window opening effects on structural behavior of historical masonry Fatih Mosque, International Journal of Architectural Heritage, 13:4, 585-599, DOI: 10.1080/15583058.2018.1447617

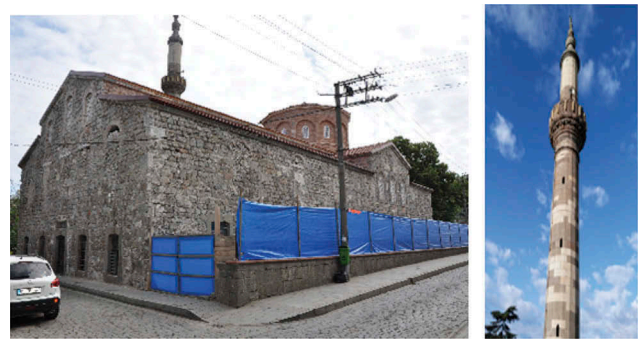
Figure 1. Views of Fatih Mosque and its minaret.

with a base area of approximately 795 m². The church was converted to a mosque in 1461, and its minaret was built adjacent to the corner of the mosque. Views of the mosque and its minaret are shown in Figure 1.

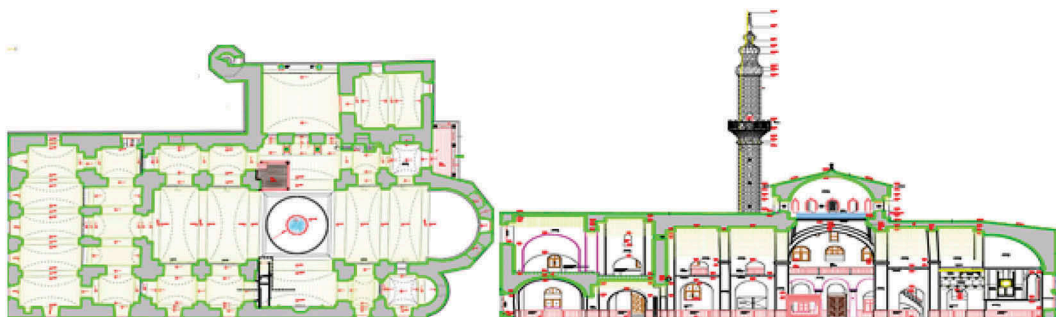
Figure 2. Drawings of the mosque and its minaret (Restoration Project 2014).

Some views of the drawings prepared according to the data taken from laser scanning are given in Figure 2. The cylindrical minaret was built with a circular cross section. The mosque with rectangular plan consists of stone-bearing walls of approximately 1000 mm in thickness.

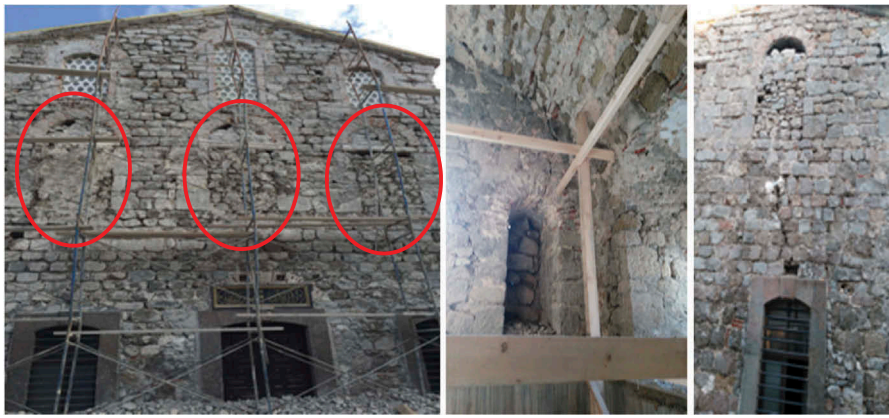
Figure 5. Views of closed window openings on the exterior walls.

deterioration of the binder mortar, joint openings, deterioration in the wooden elements, cracks, and moisture in the structural elements were observed (Figure 4). In addition, as can be seen from Figures 5–12 that previous window openings on the exterior structural walls were closed apparently to enhance the wall load-bearing capacity.

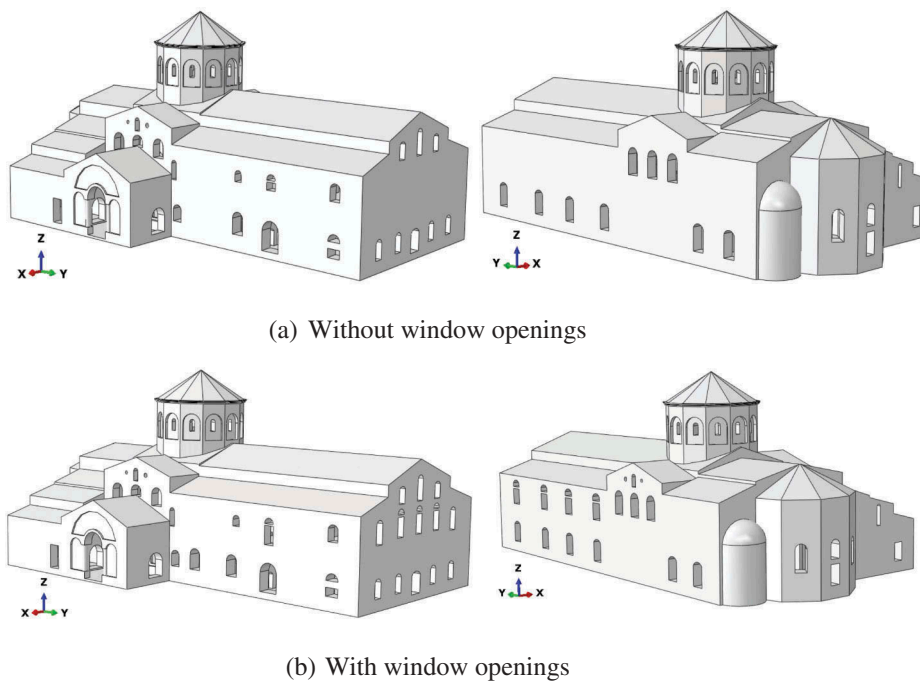
Figure 6. Solid models with and without window openings.

The three-dimensional solid models of Fatih Mosque prepared according to the restoration project and surveys are created without and with window openings separately as shown in Figure 6. As the minaret is located at the corner of the mosque, their effect on the stresses and strains in the mosque is expected to be minimum and, therefore, it is not considered in three-dimensional model of the mosque.

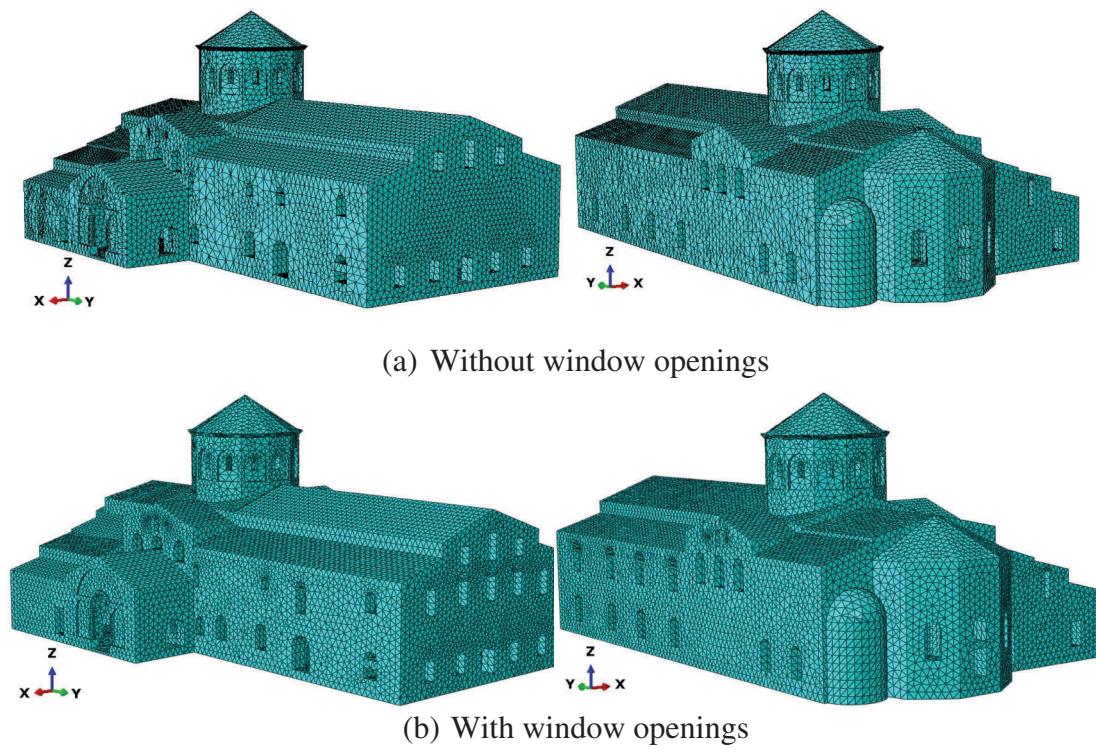
Figure 7. Finite element models with and without window openings.

The finite element models of the mosque without and with window opening are created using 249,328 tetrahedral solid elements and 997,312 nodal points, and 246,344 tetrahedral solid elements and 954,402 nodal points in Abaqus (2010), respectively. Three-dimensional finite element models of the mosque are given in Figure 7. The mechanical properties of

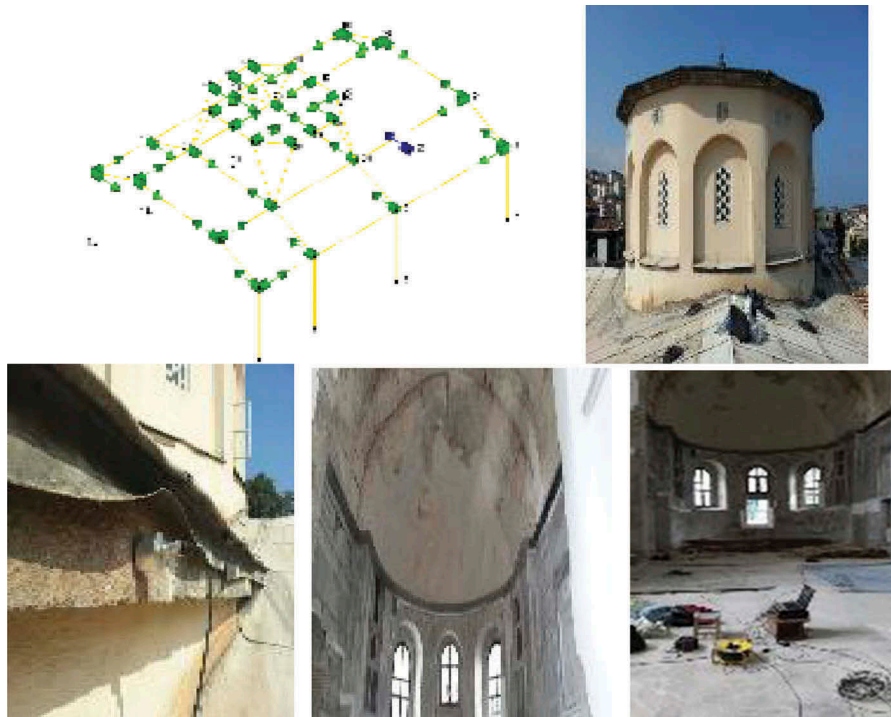
Figure 8. Accelerometer layout and images from the measurements.

Since the mosque is a complex structure, ambient vibration measurements were implemented on the

mosque for initial calibration and validation of the finite element model. Experimental natural frequencies, mode shapes, and modal damping ratios of Fatih Mosque are determined by Ambient Vibration Tests. Sensitive seismic accelerometers were used in the measurements. The signals from the accelerometers were collected with the help of the data logger unit and transferred to the computer. The images of accelerometer placement and dynamic measurements are given in Figure 8. Frequency spectrum determined from the tests using Enhanced Frequency Domain Decomposition technique are given in Figure 9.

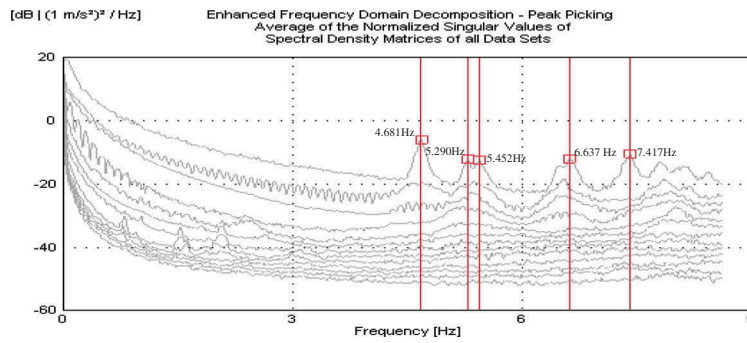
Figure 9. Frequency spectrum determined from the tests.

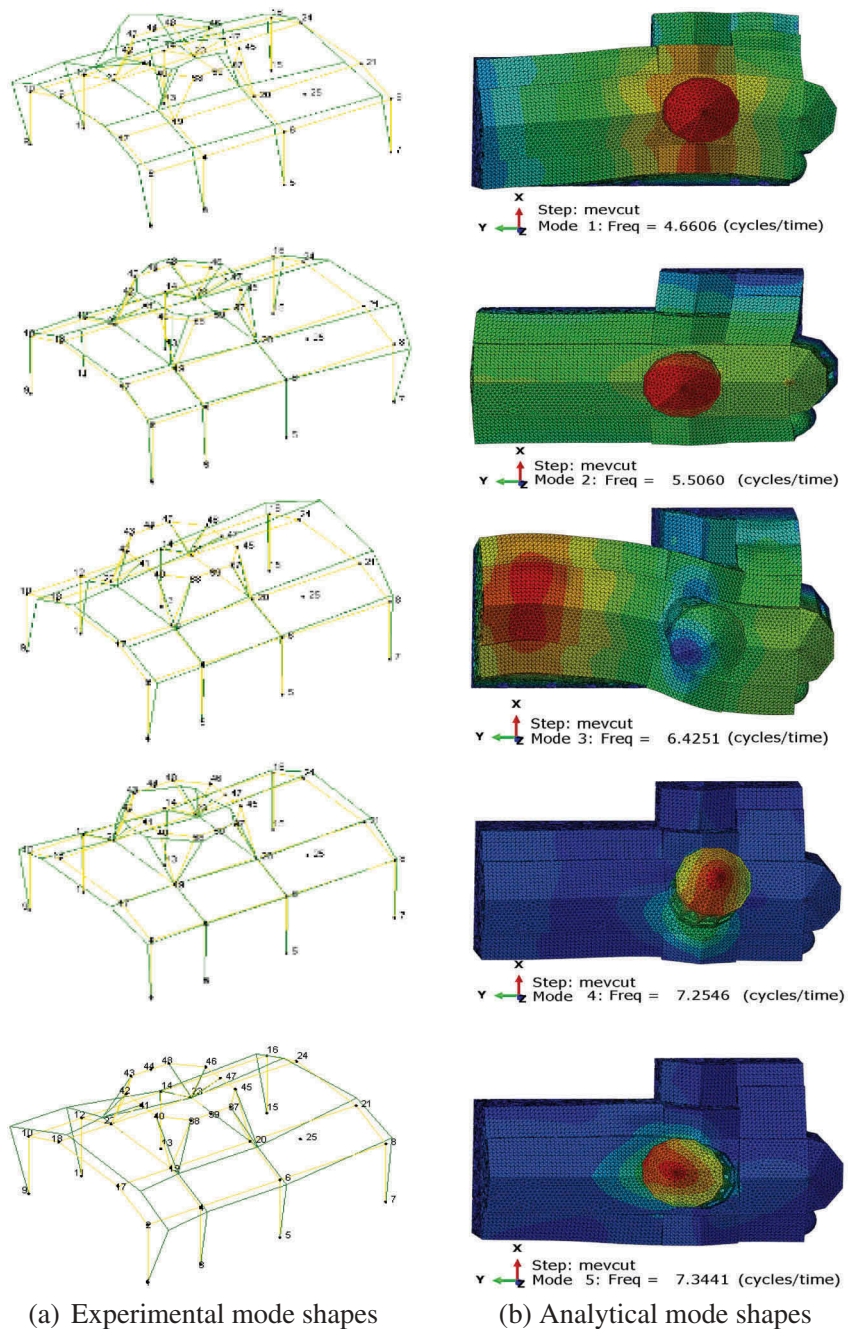
Figure 10. Experimental and analytical mode shapes of the mosque.

The first five frequencies obtained from the initial finite element model of the mosque are given in Table 4. It can be seen from Table 4 that there are significant differences between the frequencies obtained from the initial finite element model and experimental tests. For this reason, initial finite element model of the mosque with blind window opening is updated by approximating the theoretical frequency values to the experimental frequency values. It is well known that historical masonry mosques and churches are complex structures having many elements and materials. The geometrical dimensions were more accurately measured than the material properties of the mosque, the material properties is likely to have wider variation from one point to another of various structural elements of the mosque. Therefore, the average material properties are only selected for the initial model calibration as the material properties of the mosque walls were determined only at six points given in Table 2. The differences between the experimental and analytical frequencies after the model updating are greatly reduced, and the frequency values of the updated model with blind window opening are close to the experimental results as shown in Table 4. The experimental and updated theoretical mode shapes are given in Figure 10. It can be seen from Figure 10 that the experimental and analytical mode

shapes are compatible with each other. The updated finite element model with and without window opening are used in static and dynamic analyses.

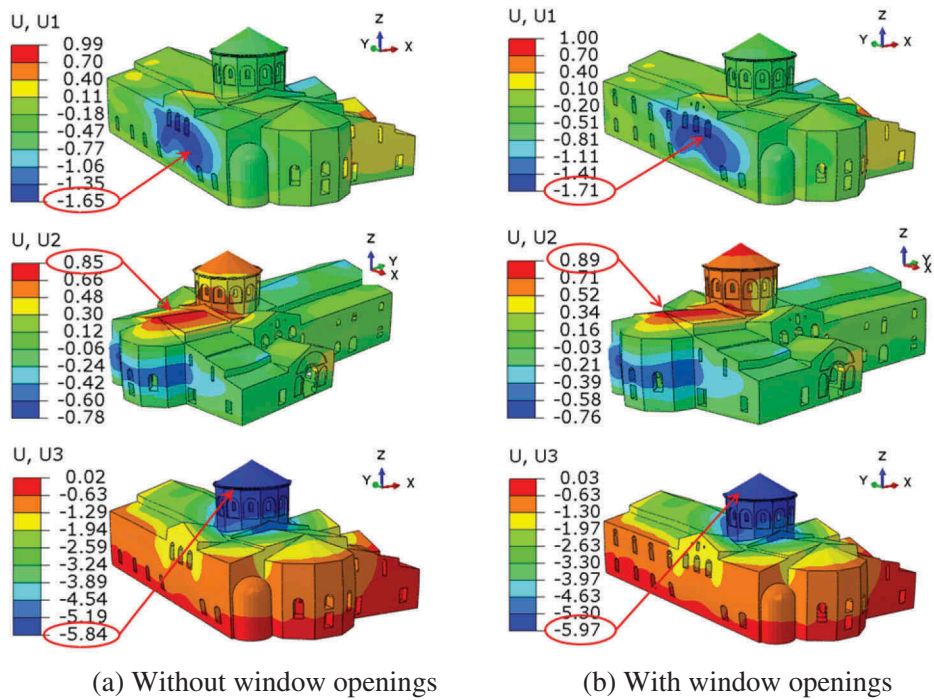
Figure 11. Static displacement propagations in transverse (U1), longitudinal (U2), and vertical (U3) directions.

First, the static behavior of the mosque is investigated in cases of window opening are blind and open. The static analyses are carried out under the mosque's self weight and live loads. A live load of 5 kN/m² is considered in the analysis as recommended for design of mosques in Turkish load standard TS498 (1997). Figure 11 shows the maximum static displacements and distributions of U1, U2, and U3 obtained in the transverse (X-axis), longitudinal (Y-axis), and vertical (Z-axis) directions from the finite element models with and without window opening. The maximum static vertical, transverse and longitudinal displacements are calculated as 5.84 mm, 1.65 mm, and 0.85 mm, respectively, in the case of blind window opening, whereas the corresponding values in the case of with window opening are 5.97 mm, 1.71 mm, and 0.89 mm, respectively. The above results indicate that the existence of the 12 windows has slightly increased the maximum static displacements. When the displacement propagations given in Figure 11 are examined, the static displacements occurring in both cases of window opening generally shows similar behavior. It can be stated that opening of the blind windows slightly affects static behavior of the mosque.

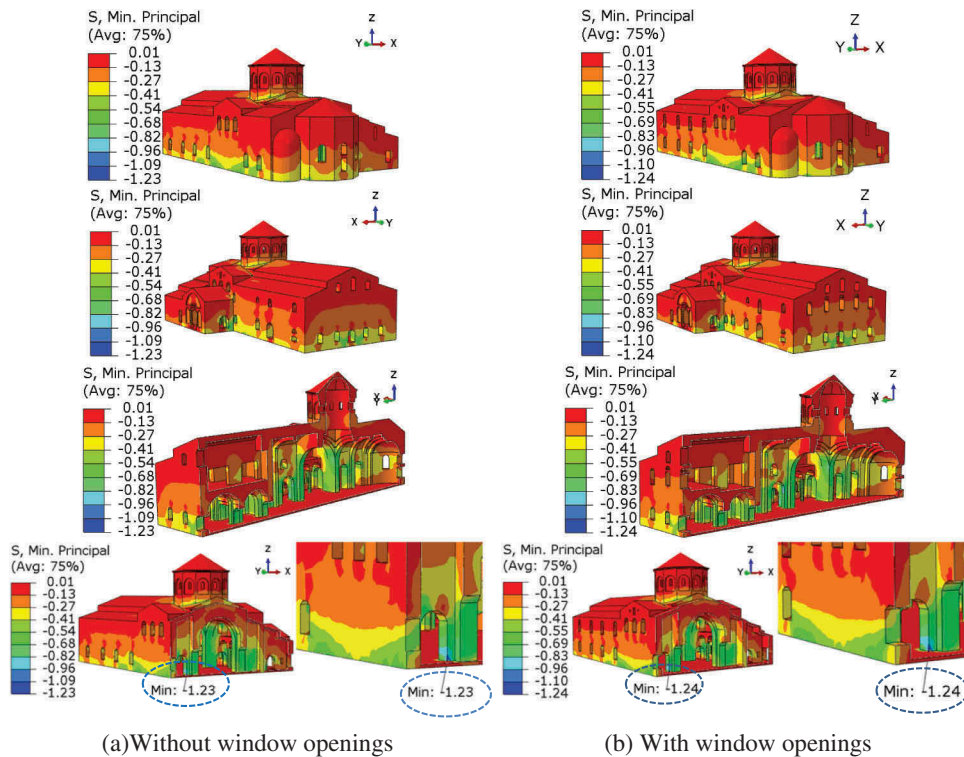
Figure 12. Propagations of minimum static principal stresses.

The minimum (compressive) and maximum (tensile) static principal stresses obtained when the window openings are blind and open are given in Figures 12 and 13. When the window openings are blind, the maximum and minimum static principal stresses under the mosque's self weight and live loads are obtained as 0.51 MPa and 1.23 MPa, respectively, near the bottom of columns. It can be seen from Figure 4 that real damages occurred at the bottom of the columns. When the window openings exist, the maximum and minimum static principal stresses are determined as 0.53 MPa and 1.24 MPa, respectively. The maximum and minimum static principal stress values obtained in cases of with and without window openings are close to each other. However, as can be seen from Figures 12 and 13, these values of maximum and minimum static principal stresses occur only in a small local region. The increment in stresses is mainly due to stress concentration at corners and finite element mesh refinement of this region. The maximum and minimum principal stresses occurring throughout the mosque are smaller. It is observed that the maximum principal static stress distributions increase in case of windows are open. However, the minimum principal static stresses are close to each other in the case where the window openings are blind and open.

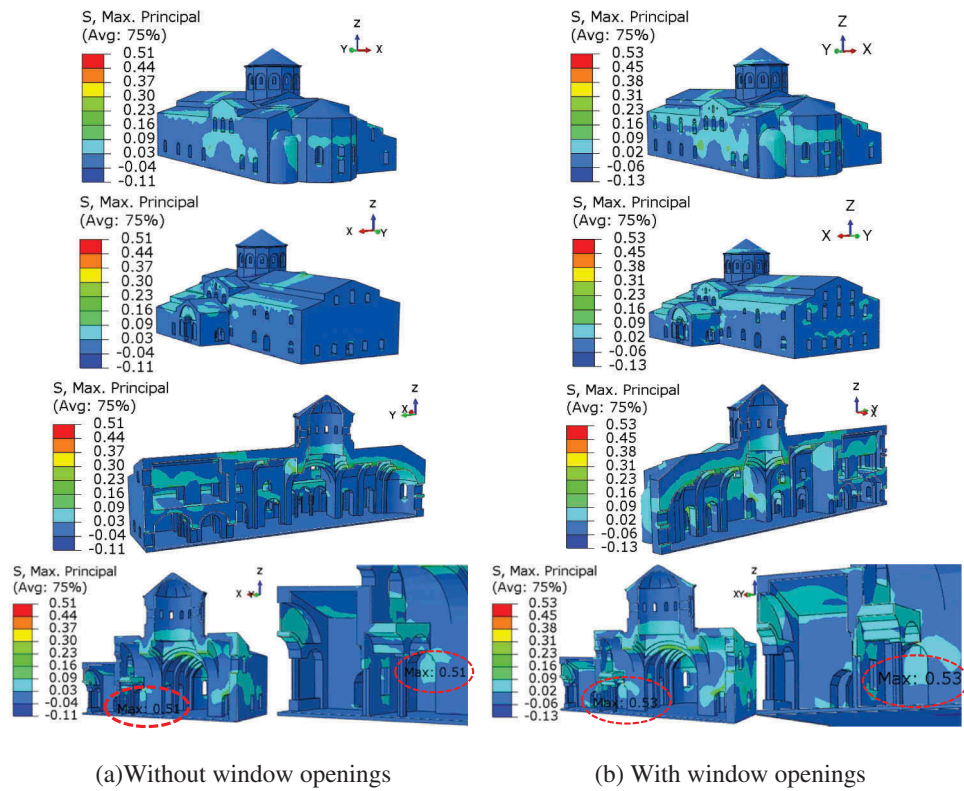
Figure 13. Propagations of maximum static principal stresses.

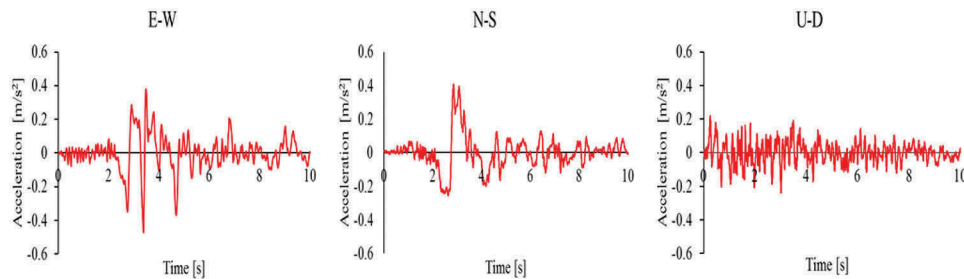
Figure 14. Acceleration records of Erzincan earthquake (1992) in east-west (E-W), north-south (N-S), and vertical (U-D) directions (Web-2 2017).

The Erzincan earthquake in 1992, which is the largest earthquake occurred nearest to Trabzon city, is selected for the seismic analyses. Baseline corrected original acceleration records of the Erzincan earthquake in east-west (E-W), north-south (N-S), and vertical (U-D) directions are depicted in Figure 14. The peak ground acceleration (PGA) values of the earthquake in east-west (E-W), north-south (N-S), and vertical (U-D) directions are 449.96 cm/s^2 , 385.52 cm/s^2 , and 192.164 cm/s^2 , respectively. In the time history analysis, the first 10 seconds of the E-W, N-S, and U-D acceleration components are simultaneously applied to the mosque model with and without window openings in the transverse (X-axis), longitudinal (Y-axis), and vertical (Z-axis) directions, respectively. During earthquake analyses, self weight and 5 kN/m^2 live load were

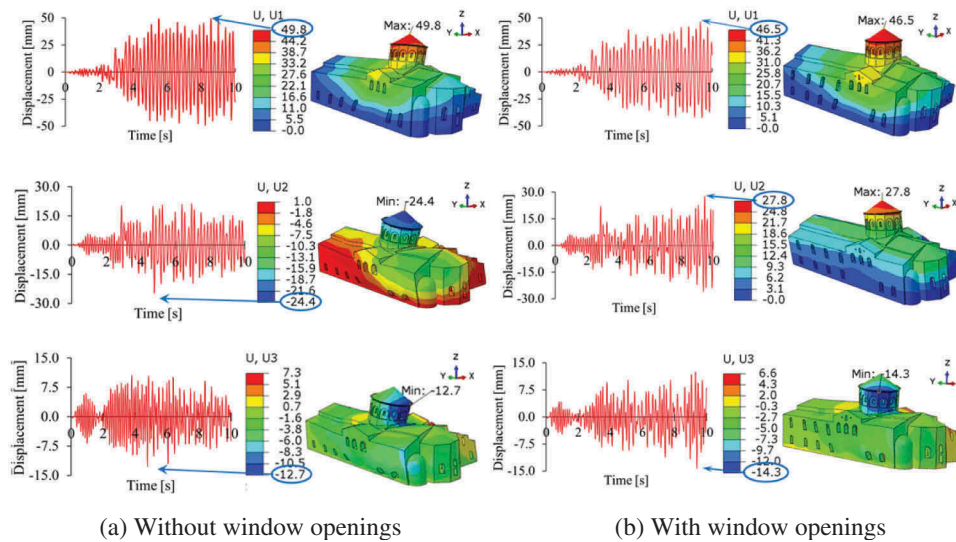
Figure 15. Time histories and propagations of dynamic displacement in transverse (U1), longitudinal (U2), and vertical (U3) directions.

The maximum dynamic displacements and distributions of U_1 , U_2 , and U_3 obtained in the transverse (X-axis), longitudinal (Y-axis), and vertical (Z-axis) directions from the finite element models with and without window opening are given in Figure 15. The maximum dynamic transverse, longitudinal and vertical displacements were obtained as 49.8 mm , -24.4 mm , and -12.7 mm in the case of blind windows; and 46.5 mm , 27.8 mm , and -14.3 mm in the case of opened windows, respectively. The maximum dynamic displacements occur on the dome. In the case of opening of the blind windows, a decrease in transverse displacement, an increase and direction change in

longitudinal displacement, an increase in vertical displacement are observed. In addition, as can be seen from Figure 15 that there is a change in the frequency contents of dynamic displacements and significant differences occur in the dynamic displacement distributions. The displacement time histories and occurrence times of peak values change with considering window openings during the earthquake. It can be also seen from the displacement colour contours in the mosque that displacement distributions change with opening windows.

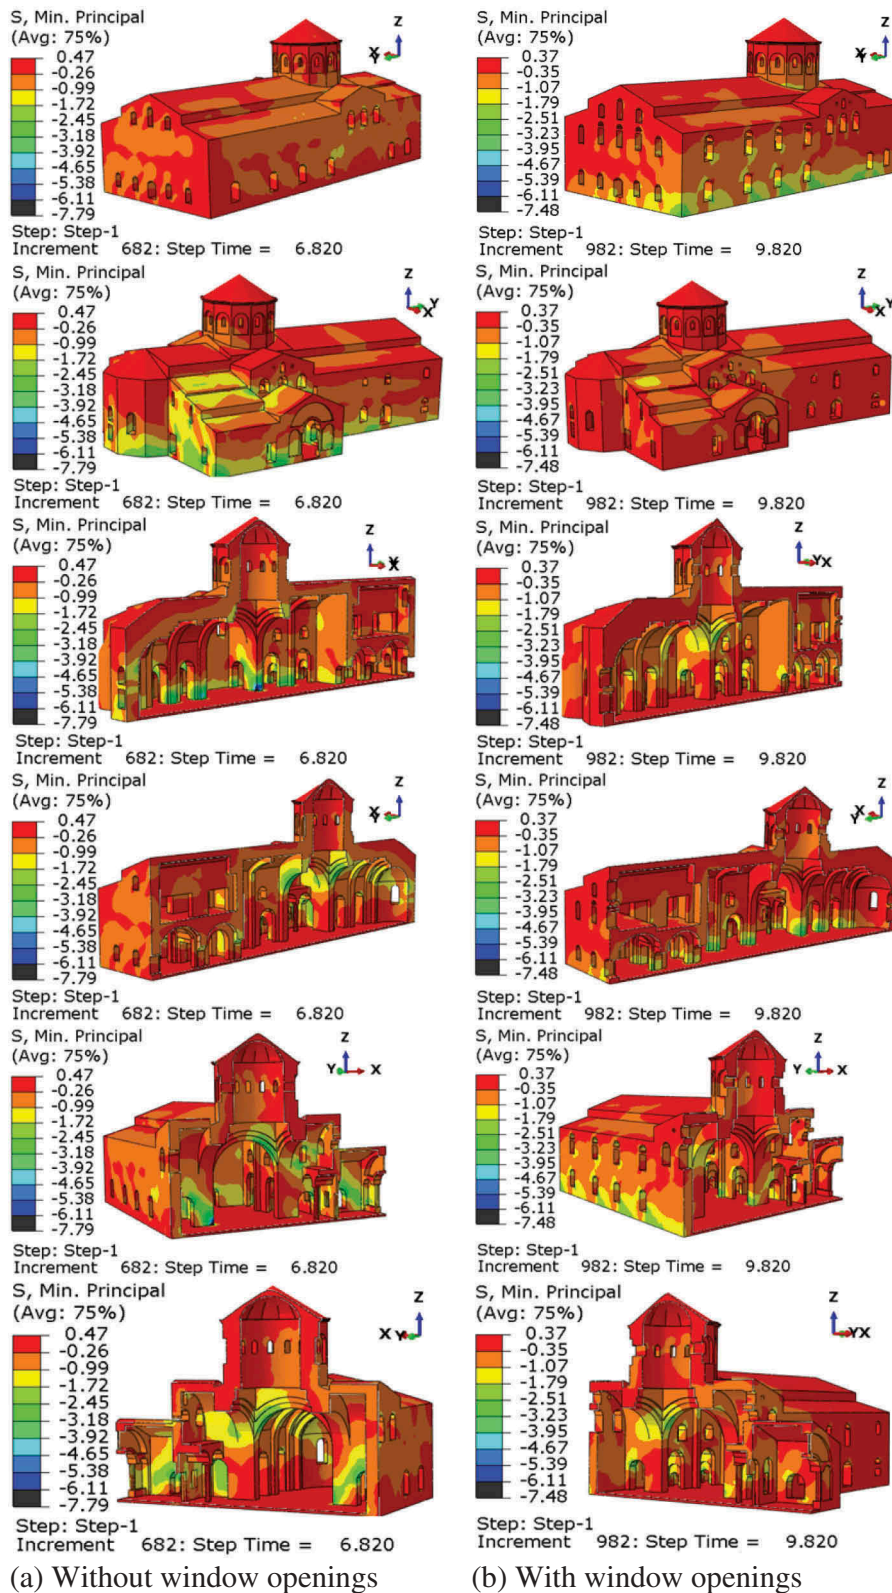
Figure 16. Propagations of minimum principal stresses under self weight, live, and earthquake loads.

The minimum (compressive) and maximum (tensile) principal stresses obtained under self weight, live, and earthquake loads are shown in Figures 16 and 17 for blind and open window cases. The minimum and maximum principal stresses are calculated as -7.79 MPa and 1.95 MPa, respectively, in the case of blind windows. If the blind windows are open, the minimum and maximum principal stresses are obtained as -7.48 MPa and 1.62 MPa. In Figures 16 and 17, the minimum and maximum principal stresses were scaled according to the wall

compressive (6.1 MPa) and tensile strengths (0.61 MPa), respectively. The minimum and maximum principal stresses occur at different times in the cases of blind and open windows. The regions where the maximum and minimum principal stress values are formed are shown in gray and black colors, respectively, in the stress distributions. In other words, the areas where the stresses exceeded the wall compressive and tensile strengths are shown black and gray colors, respectively. As can be seen from Figure 16, in the cases of the blind and open windows, the minimum principal stress value only occurs in a localized zone and exceeds the wall compressive strength in this region. However, the maximum principal stresses exceed the wall tensile strength more widely in both blind and open window cases (Figure 17). When the blind windows are opened, the maximum principal stress distributions with gray colors, which exceed the wall tensile strength, increase especially in the column elements bearing the dome, and the dome and body connection. The values of principal stress distributions in this regions show a significant increase from 0.61 to 1.95 MPa.

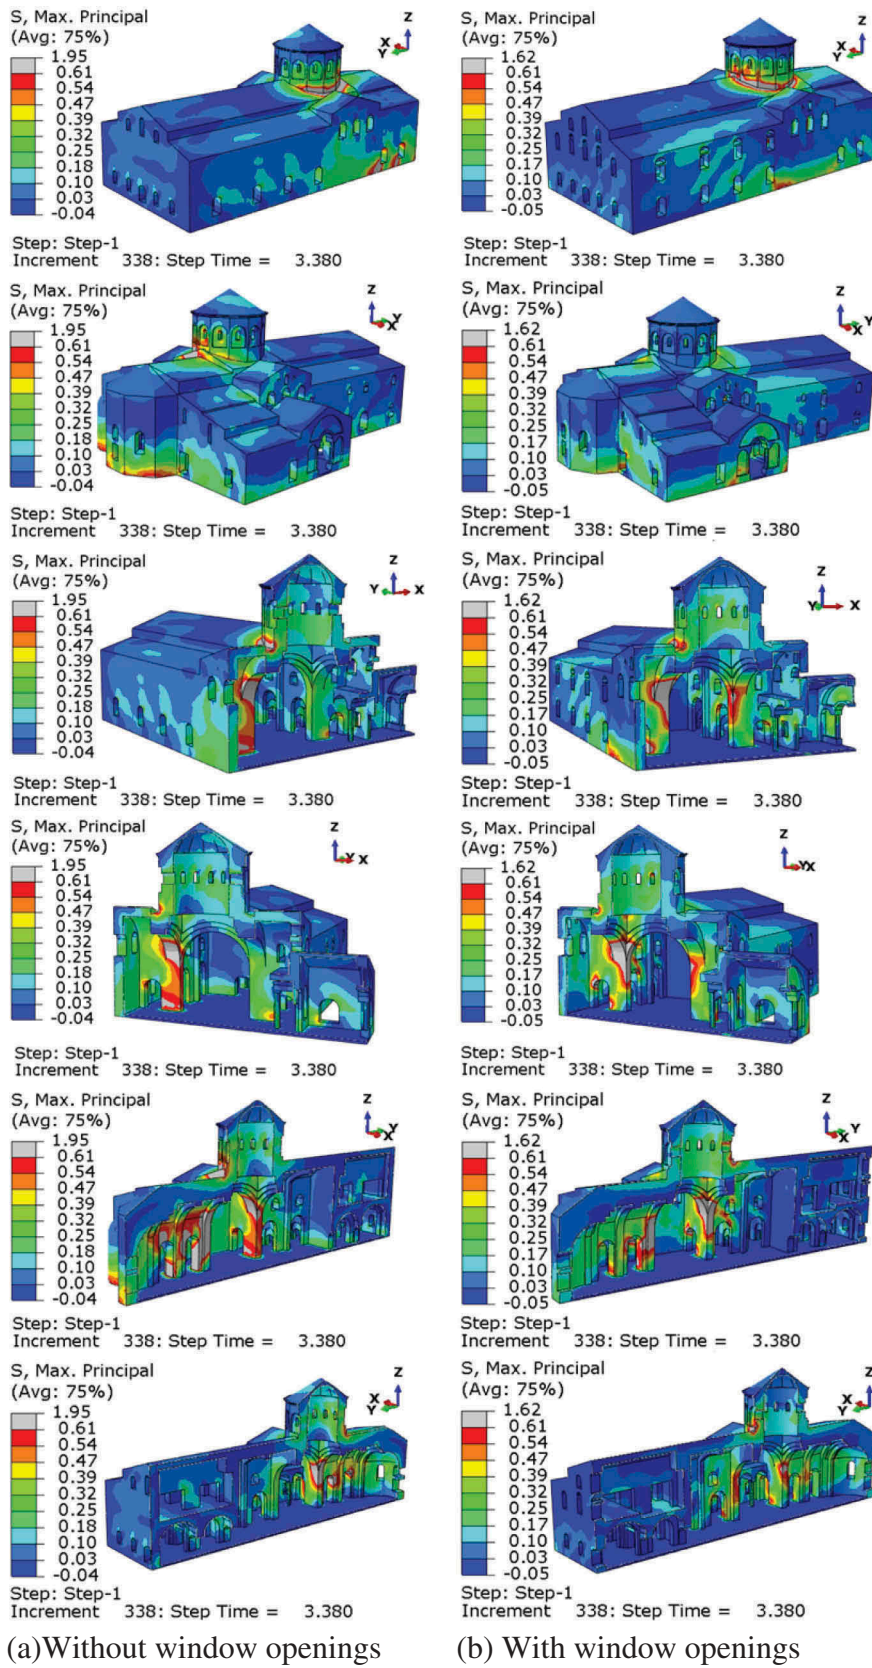
Figure 17. Propagations of maximum principal stresses under self weight, live, and earthquake loads.
